# Remediation project at Loch Flemington: A shallow loch in deep trouble?

Sebastian Meis (CEH); Bryan Spears (CEH); Stephen Maberly (CEH); Rupert Perkins (University of Cardiff). Contact: sebisa@ceh.ac.uk

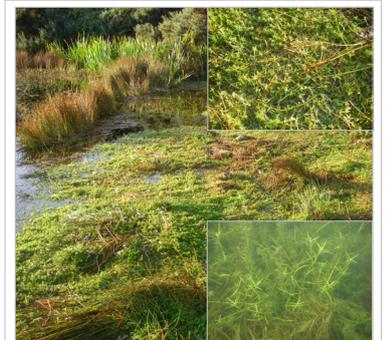
**Figure 3** *Crassula helmsii* was first observed in semi-aquatic patches along the water line. Submerged stands were also found later in the growing season (inset bottom right).

New Zealand pygmyweed (*Crassula helmsii*) was first observed in August 2009 (Fig. 3). *Crassula helmsii* can form very dense stands, which can outcompete other aquatic plants, causing loss of habitat heterogeneity & species diversity.

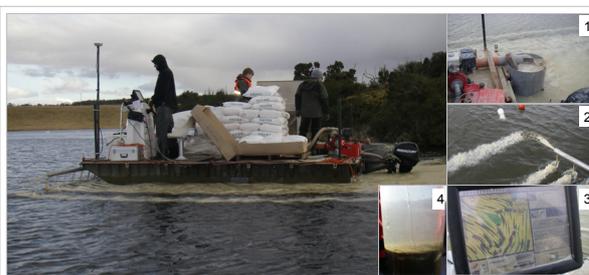
**Figure 6** Phoslock® was applied as a slurry (inset 1 & 2) from a GPS guided (inset 3) pontoon. One day after the application signs of Phoslock® were visible in the sediment (inset 4).

The timelines for the project are shown (Fig 5). In order to reduce internal P loading in Loch Flemington a lanthanum modified clay (Phoslock®) was applied in March 2010 (Fig. 6). Monthly post-application monitoring to assess effects on site attributes will continue for at least a year to evaluate the success of the treatment. Trials investigating methods of controlling invasive macrophytes (i.e. shading and clear cutting) are ongoing.
