# Het Groene Eiland, Appelterm, Netherlands

## Summary

**Aim:** Prevention of blue green algae blooms by reducing phosphorus concentrations

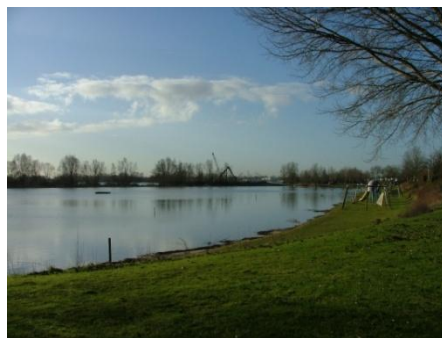
Reports on water quality in "The Gouden Ham" in 2006 and 2007 indicated algal blooms dominated by the blue green algae Microcystin with levels above the 20  $\mu\text{g/L}$  threshold which resulted in public swimming bans during both these years.

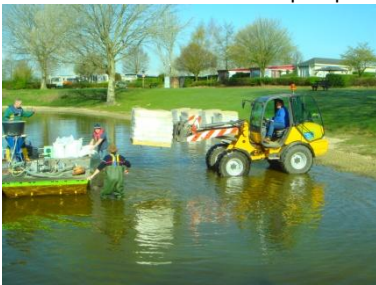
Eleven tonnes of Phoslock® were applied on the 16<sup>th</sup> and 17<sup>th</sup> of April using a pontoon based application system. It was intended that the application would remove 110 kg Phosphorus from the available nutrient pool of both the water column and the releasable fraction of the sediment for the entire lake. Phoslock® was mixed with in situ water pumped

from the lake in a venturi mixing system installed on a pontoon and then sprayed evenly over the surface of the lake. No Phoslock® was applied to the shallow areas near the shore or the swimming areas. The application was performed by Bentophos GmbH.

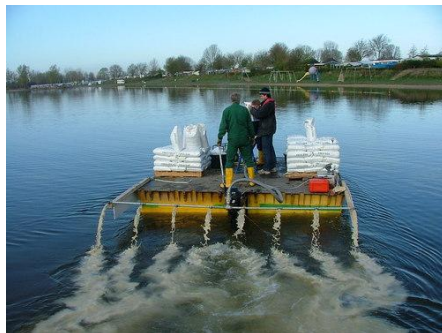
An additional 3 tonnes of Phoslock® were applied on the 31<sup>st</sup> of March 2009 to bind new inputs of phosphorus which had entered the lake through ground

water and (unintentional) run-off from nutrient rich ash. During the second treatment, Phoslock® was applied mainly to the deeper areas. The Phoslock® granules were applied dry (without extensive mixing) to increase the settling behavior and target the sediment phosphorus rather than the water.

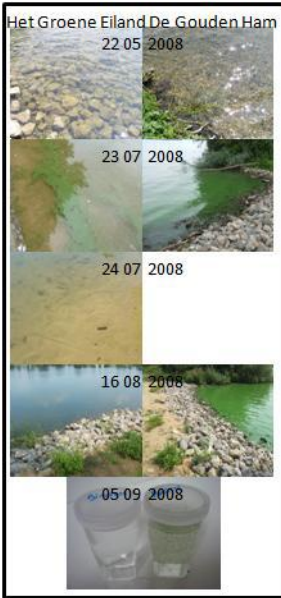
Figure 1 left: Photo series comparing the visual differences between the water at Het Groene Eiland and De Gouden Ham. (Photos courtesy of A. van Ooijen)  
Figure 2 right: Situation on 16/08/08 with Het Groene Eiland on the left and De Gouden Ham on the right (Photo courtesy of A. van Ooijen)

Ham”. Shortly after the Phoslock® application, no visual difference could be noticed. On the 23<sup>rd</sup> of July 2008, an algal bloom became apparent in both water bodies, although less pronounced in “Het Groene Eiland”. However on the 24<sup>th</sup> of July, algae in “Het Groene Eiland” were no longer visually present and the lake remained clear for the rest of the year. In

“De Gouden Ham”, on the other hand, algae remained visible from the 23<sup>rd</sup> of July until the beginning of autumn 2008. The improved situation can also be seen in the graphs, however care should be taken when comparing values from before and after the first treatment as they were obtained using different methods on a physically different water body.
